Southbury, Ballantine Park Pool Facility Evaluation Report

Ballantine Park Pool
611 Old Field Road
Southbury, CT 06488

ENGINEER'S REPORT

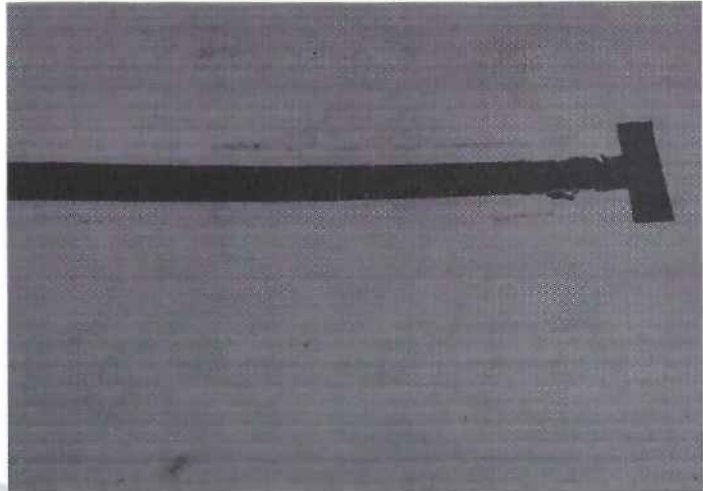
A hammer test was not performed, however, with the gutters leaking it can be assumed that there are voids around the perimeter of the deck. When looking at the pool floor it was apparent that there was settling in certain areas, refer to **Figure 2**. This could either be due to the leaking gutter or could be a sign of additional leaks possibly through cracks in the pool shell.

While there were no immediate signs of structural deterioration, there were significant amounts of spalling and cracking paint seen throughout the pool. These areas were not able to be inspected at the time of visit due to the pool being full.

Figure 2 - Settling pool floor and spalling paint at lane line

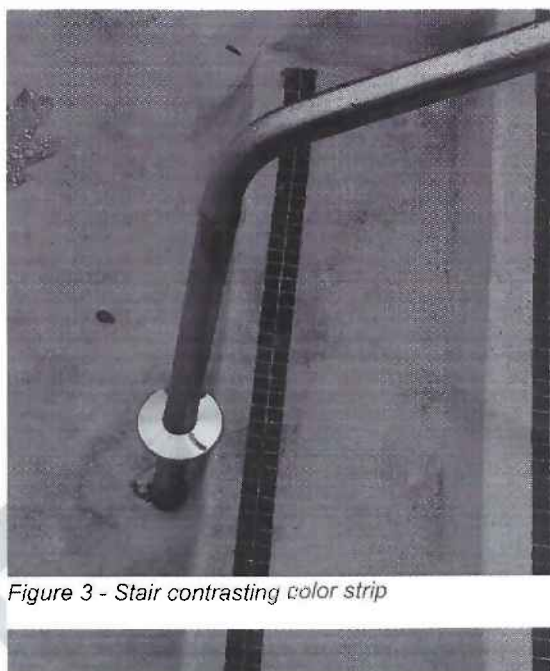
in good condition with minor repairs needed. In places where repairs were done or tiles have fallen off the Town painted contrasting strips. The town indicated that they paint the pool shell every 5-6 years.

Figure 3 - Stair contrasting color strip

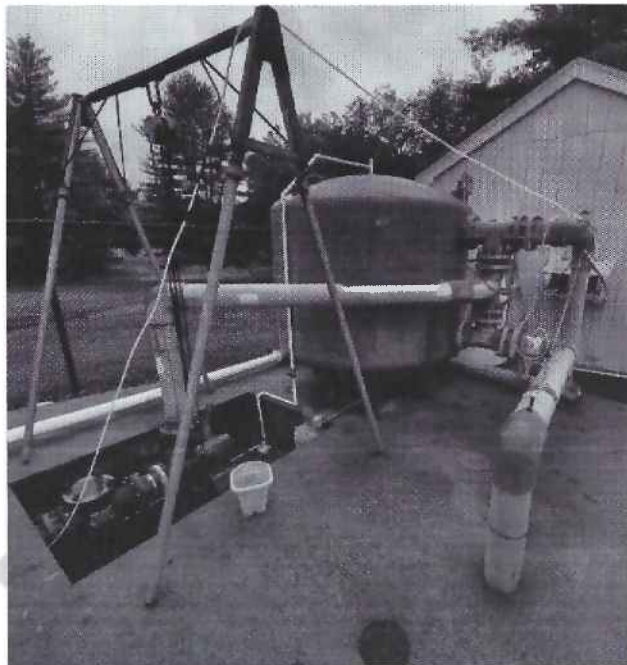
Most of the mechanical equipment for the pool is original to the pool. Since its installment the equipment has surpassed its lifetime and/or is being over worked causing further wear on the equipment. The equipment is not enclosed and therefore it has seen the effects of UV degradation and the harsh New England elements, refer to

Figure 4 - Pool Filtration system

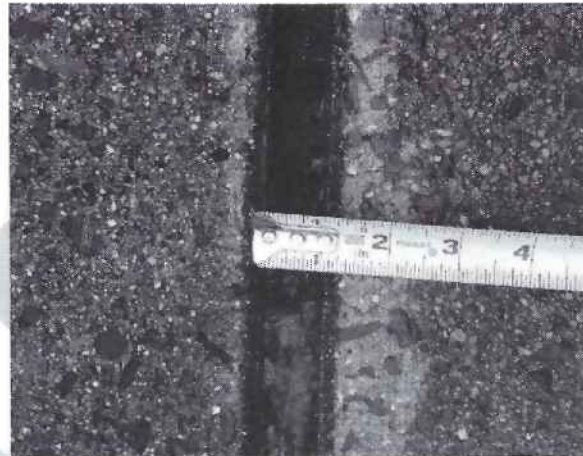
The pool deck is a series of cast in place concrete slabs. The deck is original to the pool and is in poor condition. Throughout the deck are large cracks due to the lack of saw cuts and expansion joints. There are some areas where the caulking over the expansion joint has decayed and the different sections of concrete have separated causing a hazard to patrons. It also appears that a lifeguard chair was removed and the deck anchors. The holes will need to be grouted or tiled over and the portion of the post removed, as they present a tripping and abrasive hazard to patrons.

Figure 5 - Deteriorated Expansion Joint

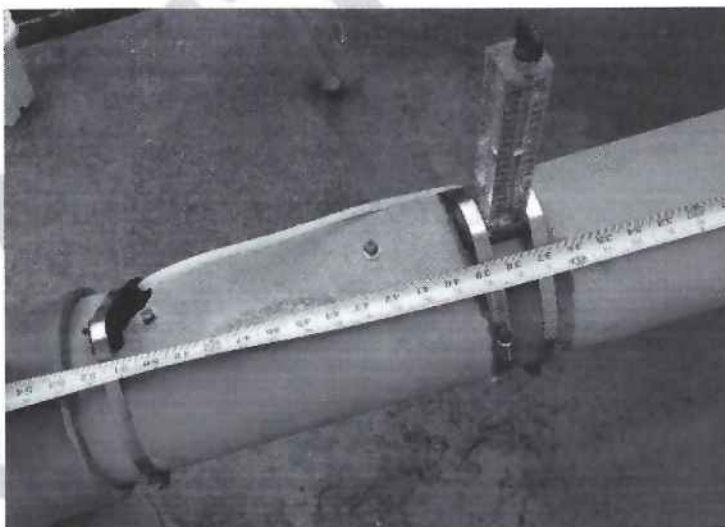
There is only one flow meter found on the swimming pool system. The flow meter is a pitot flow meter found on the return line that feeds the pool inlets. The flow meter is not properly positioned and will need to be adjusted to properly display the correct flows.

Figure 6 - Incorrect flow meter installation

Currently there is a flow meter on the filtration system, however, it is not installed per the manufacturer's recommendations. An incorrectly installed flow meter will result in inaccurate readings see **Figure 6**.

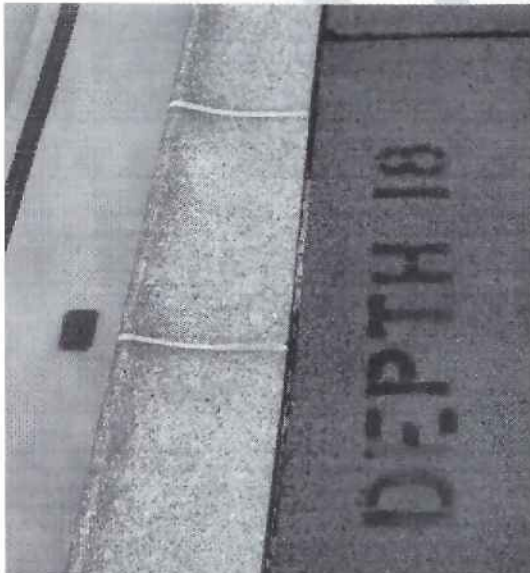
Figure 8 - Painted depth marker on deck

There are faded depths that were painted on the deck that read "DEPTH 18(1-ft 6-in), these are hard to read, don't include units such as "FT" or "IN", and do not align with the marking inside the

pool. Improper markings will need to be removed and updated so that all depth markers on the face of the wall align with the deck depth markings.

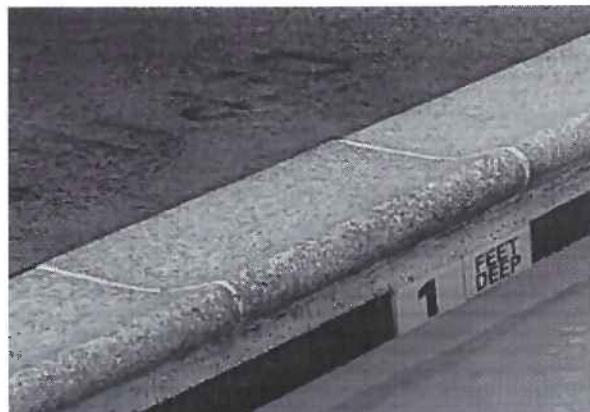
Currently there are tile depth markers on each of the faces of the pool walls that read 1-ft. The pool slopes from 1-ft to 1-ft 6-in, these depth markers will need to be replaced with more accurate depth markers. Refer to **Figure 7 and 8**.

Figure 7 - Tile depth marker on pool wall

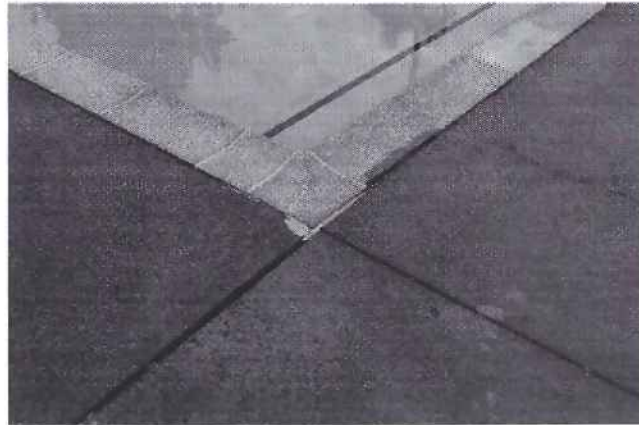
The wading pool deck is cast in place concrete slabs, connecting to the swimming pool. The deck is original to the wading pool and is in poor condition. Like the swimming pool the wading pool deck has large cracks due to the lack of saw cuts and expansion joints. There are some areas where the caulking over the expansion joint has decayed and the different sections of

concrete have separated causing a hazard to patrons.

The pool deck has separated creating large openings greater than ½-in, refer to **Figure 9**.

Figure 9 - Wading pool expansion joints

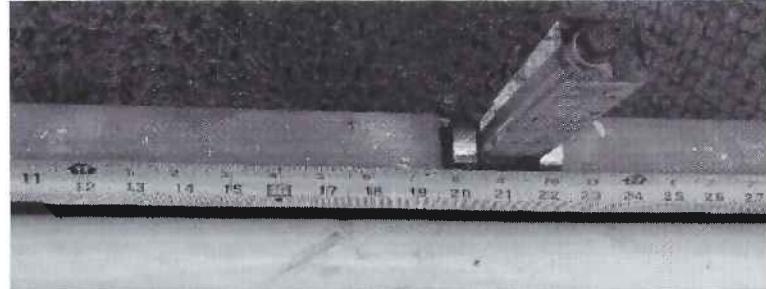
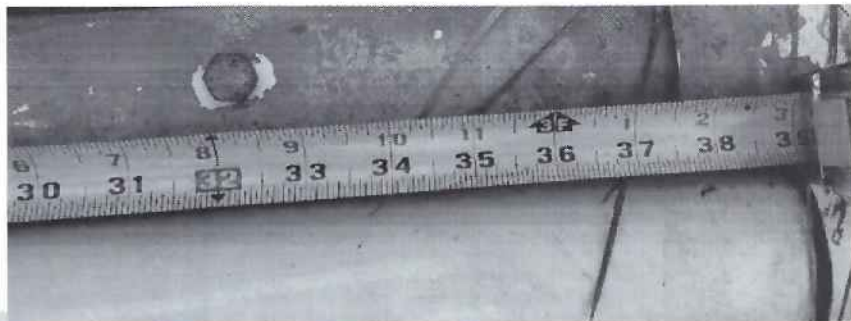
Currently there is a flow meter on the filtration system, however, it is not installed per the manufacturer's recommendations. An incorrectly installed flow meter will result in inaccurate readings. Most

Manufacturers recommend a straight pipe distance of 10 times the pipe diameter before the flow meter and straight pipe 5 times the pipe diameter after. These distances allow for a more accurate reading, see **Figure 10 and 11.**

Figure 11 - Wading pool distance prior to flow meter

Figure 10 - Wading pool distance post flow meter

The current wading pool flow meter is not able to read flow.

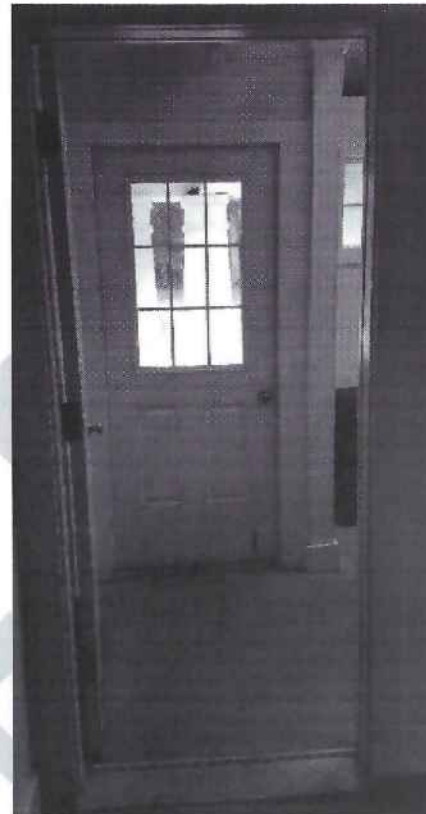
Figure 12 - Entry way to pool deck bypassing the showers

Currently patrons do not pass the toilets and showers en-route to the swimming pool.

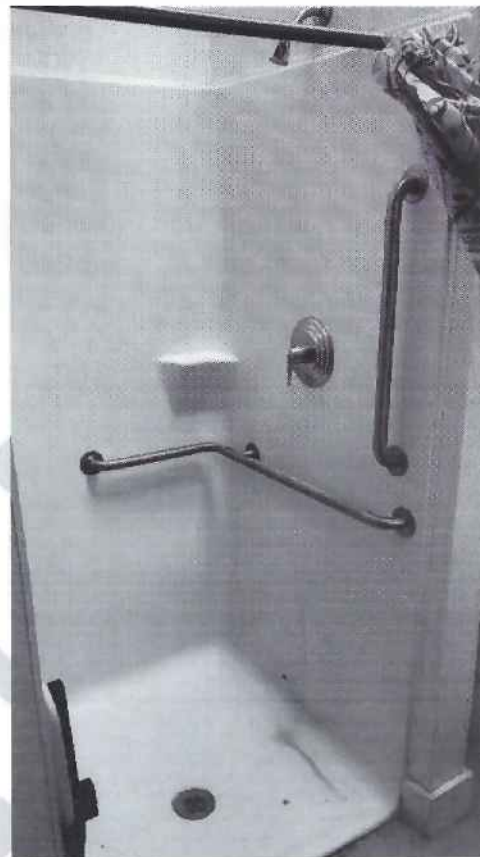
The current ADA showers do not have a spray unit with a 59 inch long hose. Refer to **Figure 13**.

Figure 13 - ADA shower
