COMPREHENSIVE CAMPUS STUDY

EXISTING SITE AND BUILDING CONDITIONS

**EXISTING SITE AND BUILDING
CONDITIONS FOR
SOUTHBURY TRAINING SCHOOL**

March 31, 2014

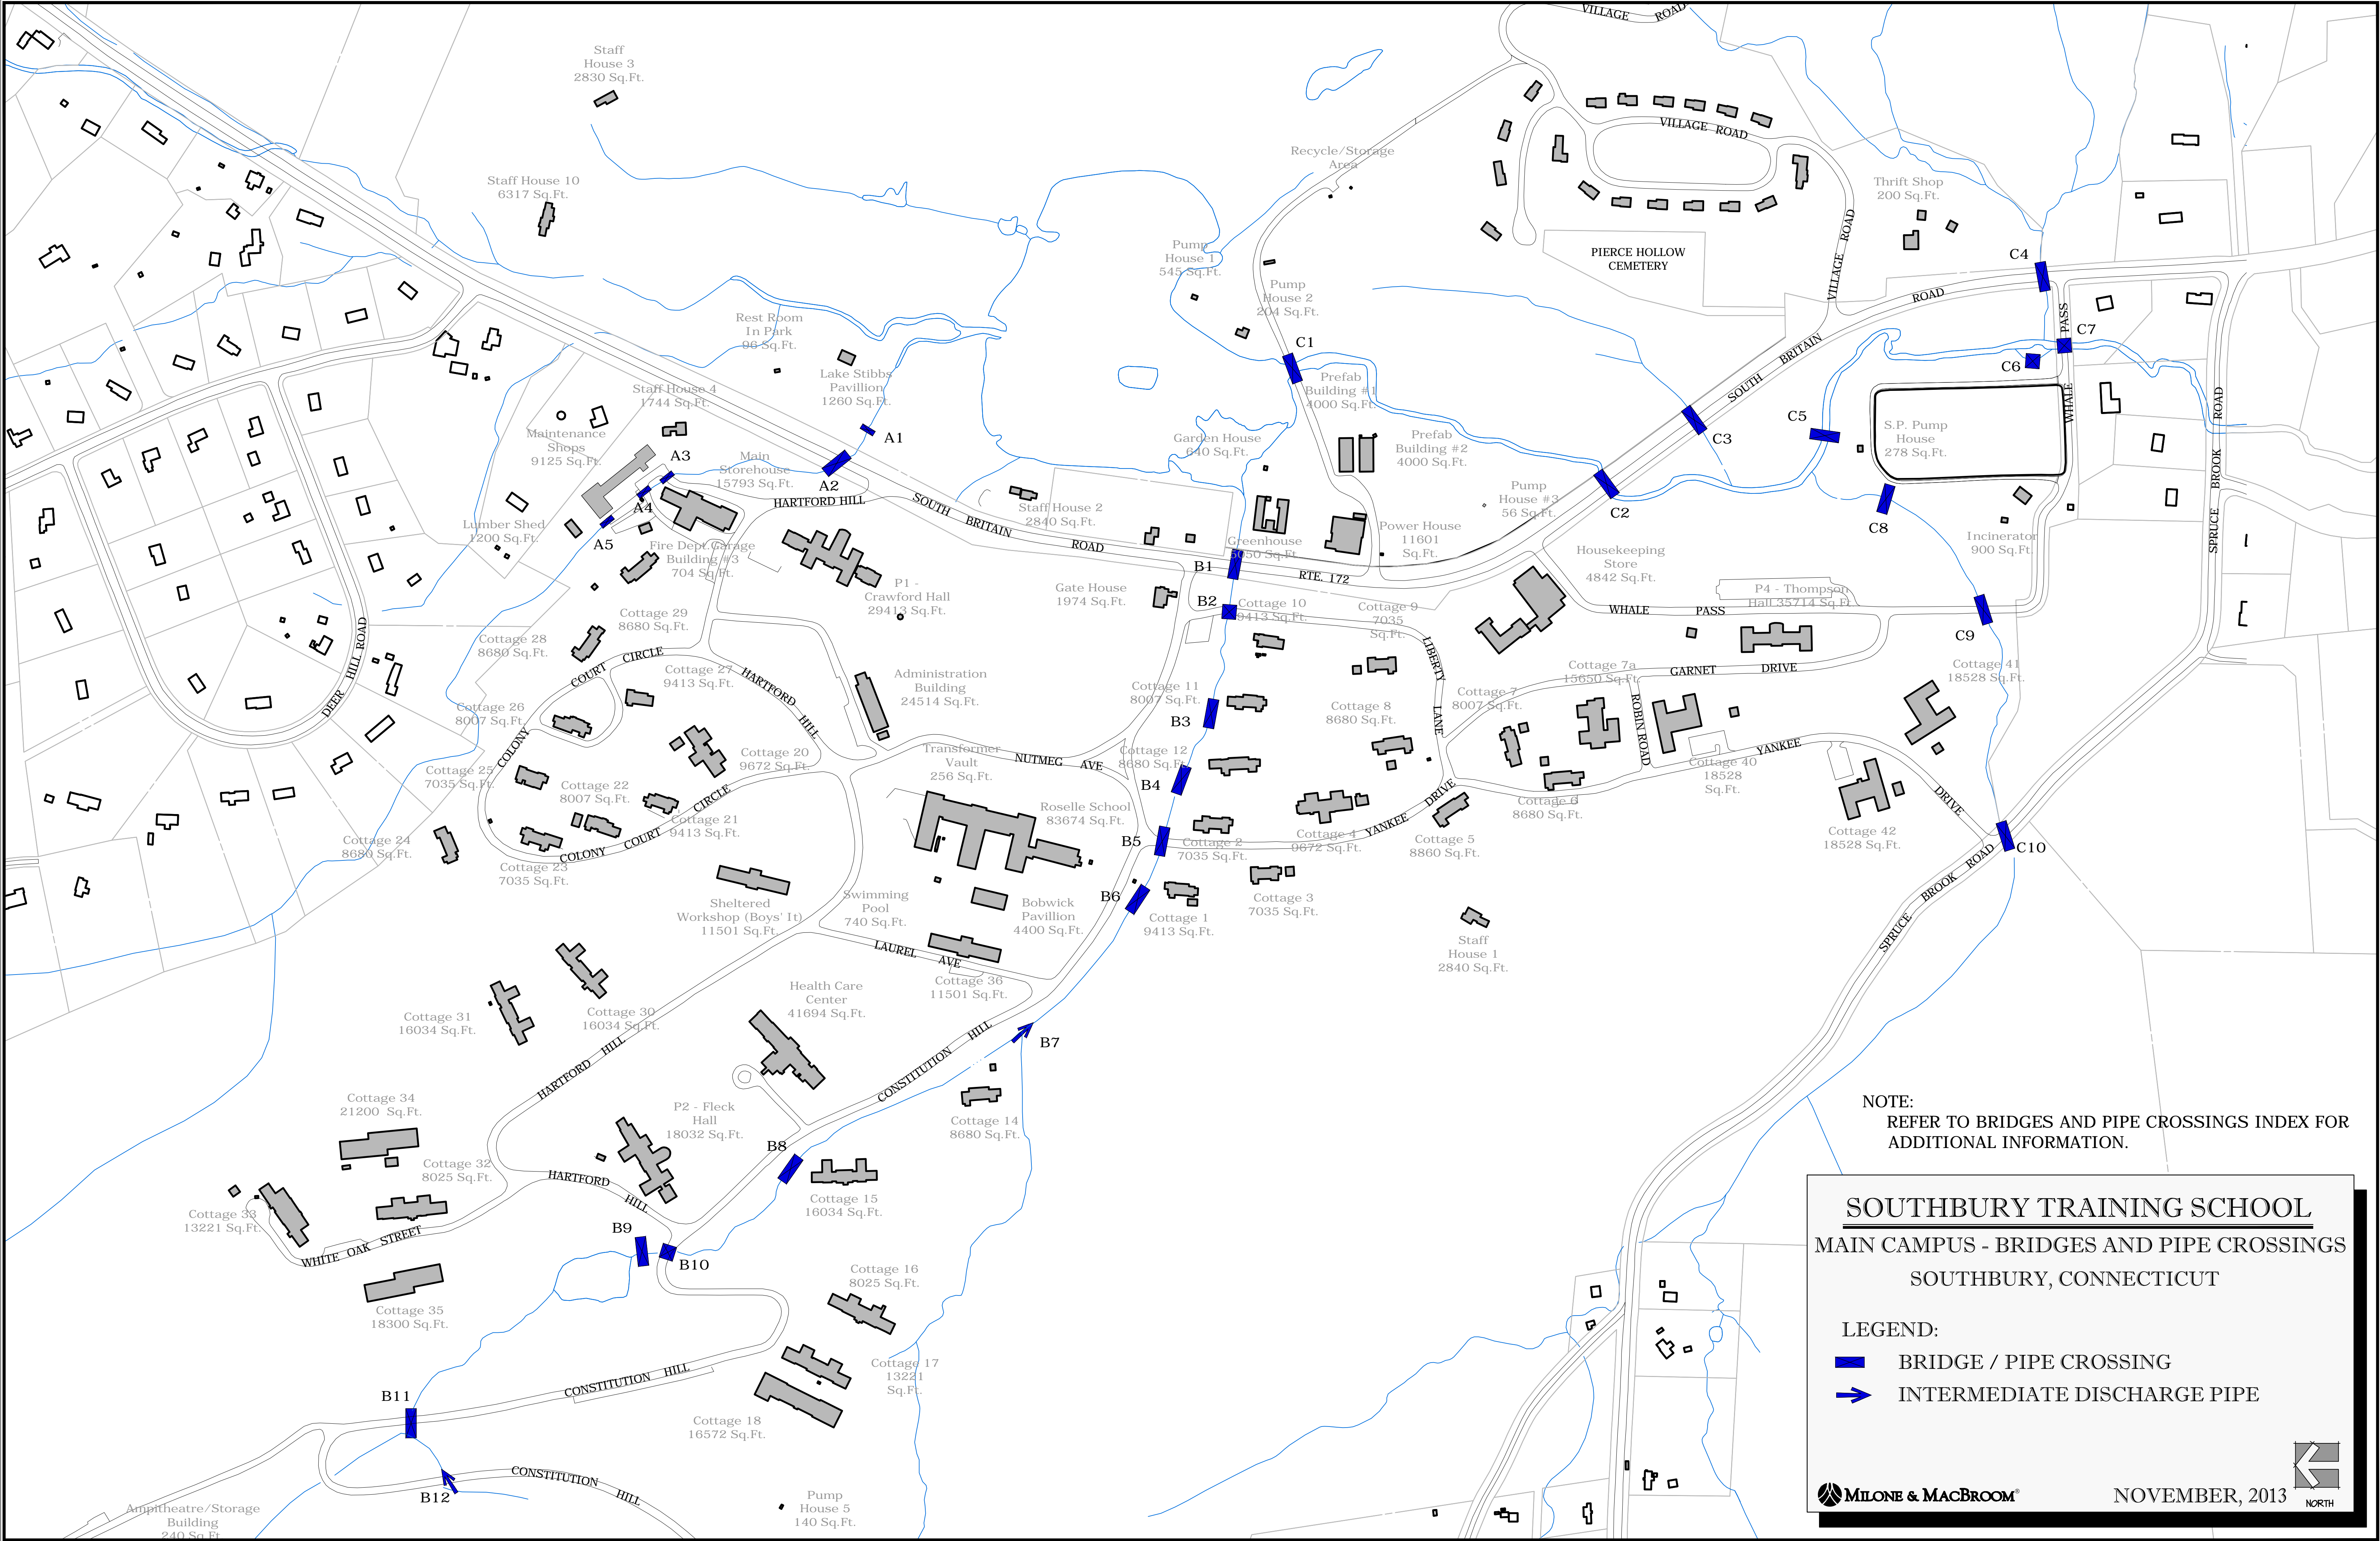
FIGURE 7 : BRIDGES & CROSSINGS PLAN

An inspection of the campus' bridges and pipe crossings was conducted. There were no major deficiencies on the main campus as routine maintenance of all such structures is evident.

Attached to many of these bridges are electrical and communication conduits that are representative of underground services. Any minor deficiencies are noted on the following Bridges and Pipe Crossings plan. An index sheet with more detail is included in the Appendix of this report.

- The roadway surface on Whale Pass, south of Thompson Hall is in need of paving as previously noted. Bridge crossing C9, shown on the Bridges and Crossings map, does not have a paved surface or guiderails. The roadway is currently comprised of base material only and has not been fine graded.

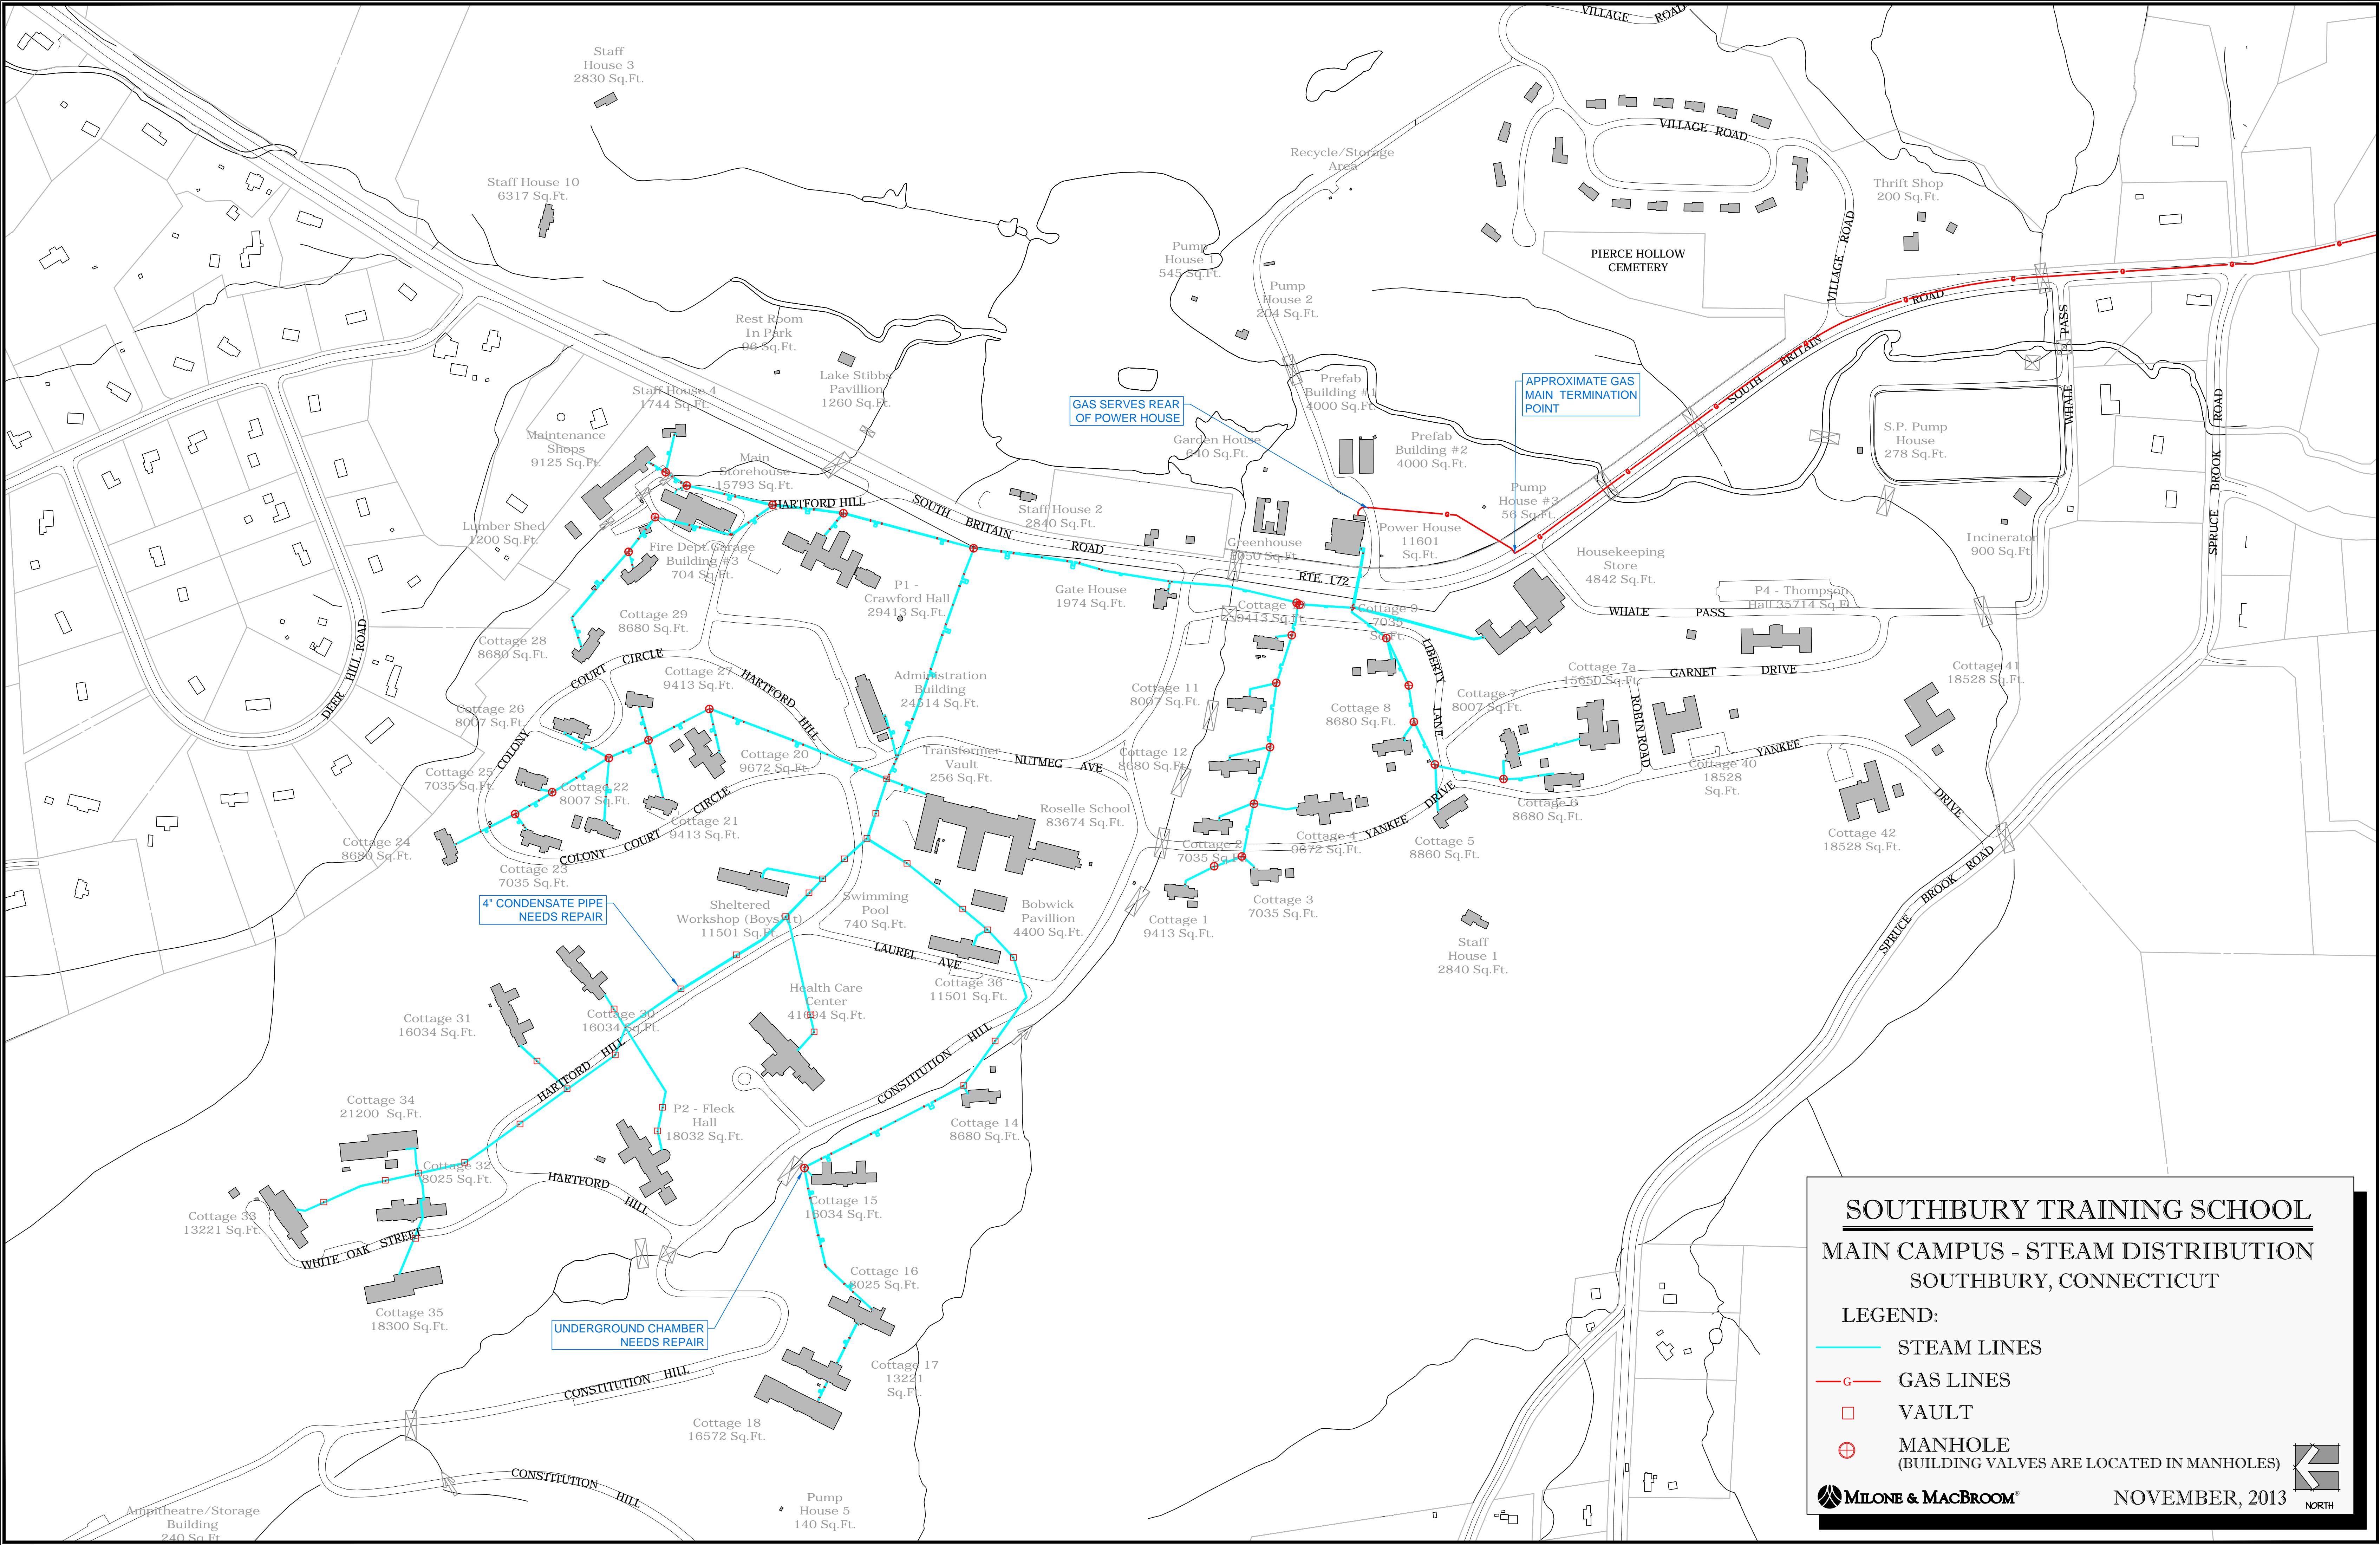
FIGURE 11 : STREAM DISTRIBUTION MAP

Recent Power House improvements include the replacement of the primary condensate return tank. Deficiencies to the steam line distribution system include the following:

- Groundwater seeping into the steam chamber at Cottage 15.
- A steam line repair from Cottage 16 westerly toward Cottage 17 was completed earlier this year. The repair extends partly into the hillside beyond the front entry of Cottage 16.

- Between the Sheltered Workshop and Cottage 30, there is a break on the 4 inch condensate line. This fault is located at the steam chamber.
- The steam distribution system is maintained on an as-needed basis and any breaks are fixed prior to the heating season. The last major replacement and repair of the steam line system was conducted in 1979. As-built mapping of this work is available upon request.

No electrical or steam distribution lines in the main campus have been taken off line. The majority of the campus is served by buried electric and steam pipes. Evidence of this buried network is most visible at stream crossings where conduit is anchored to the bridge façade. Overheard electrical is present at the sanitary pump station across South Britain Road to the Thrift Shop and from Cottage 35 to the Adventure Area.

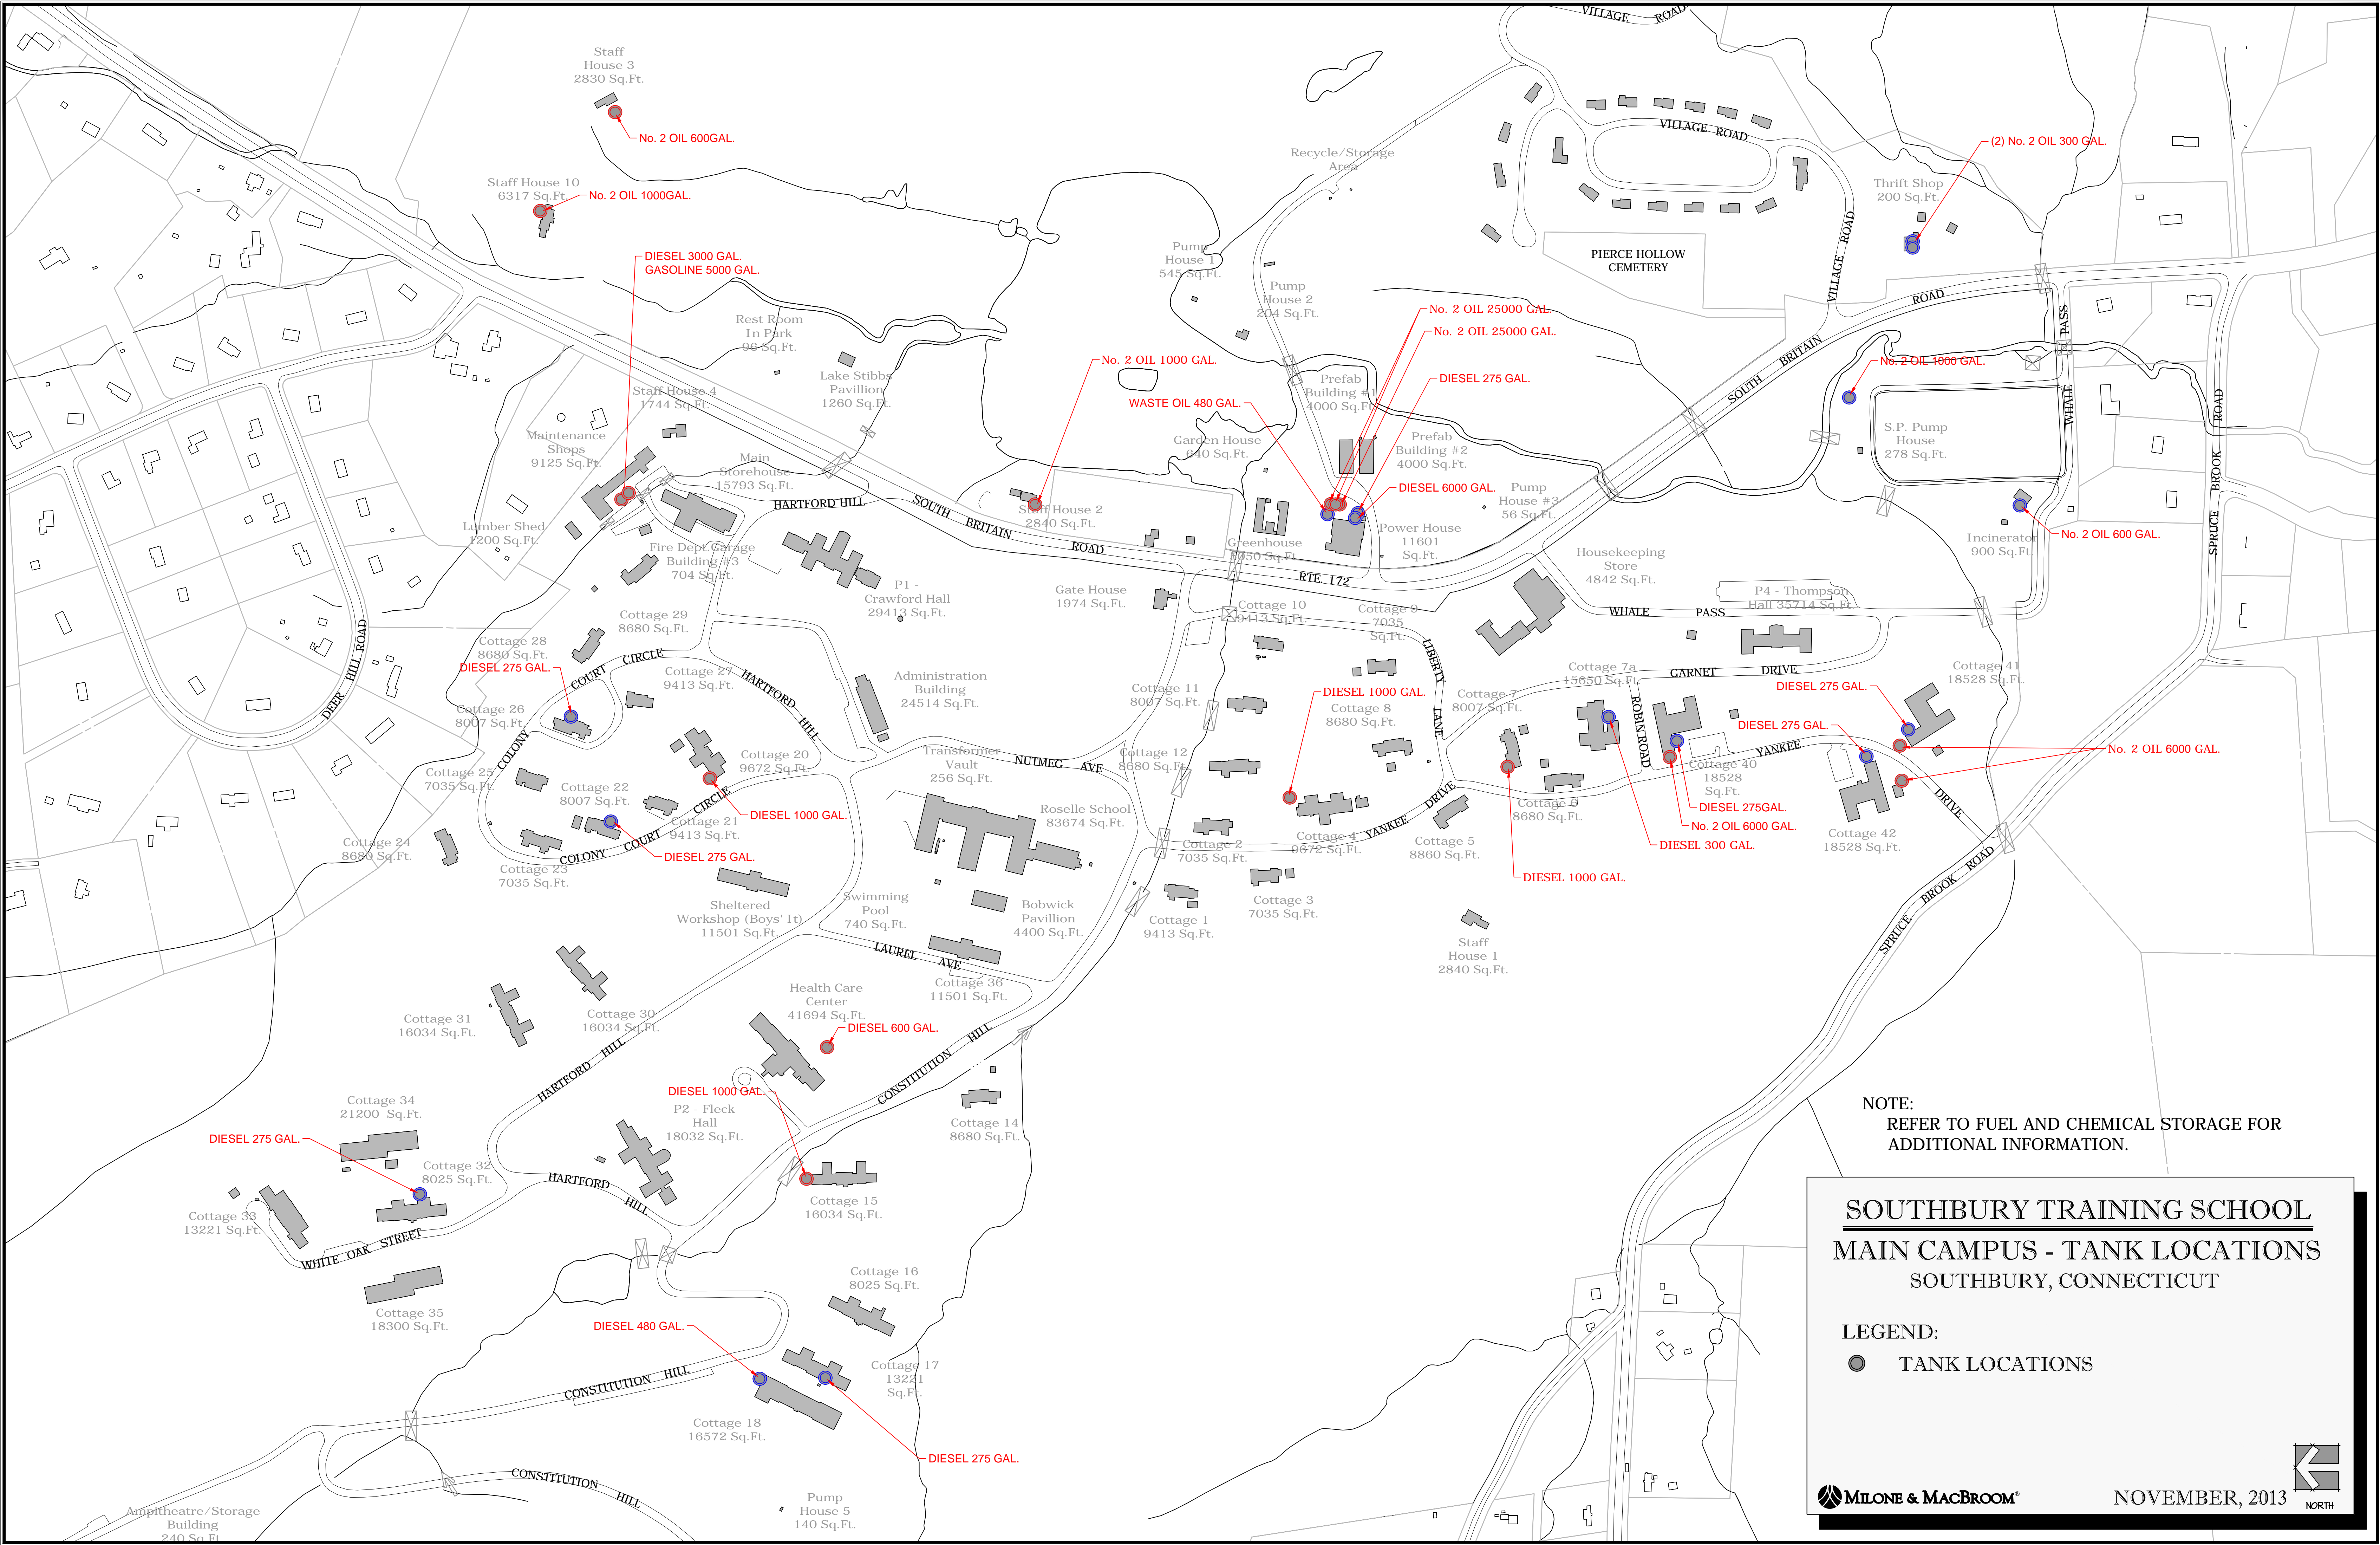
FIGURE 13: STORAGE TANK LOCATIONS

All campus fuel containers have been or will be replaced by self-contained convault tanks which provide high quality storage. The campus currently stores diesel, gasoline, and fuel oil No. 2 in multiple areas. The locations of these fuel tanks¹ are shown on the following map. There is also a table in the Appendix of this report that lists the type of fuel stored at each tank location.
