COMPREHENSIVE CAMPUS STUDY

EXISTING SITE AND BUILDING CONDITIONS

**EXISTING SITE AND BUILDING
CONDITIONS FOR
SOUTHBURY TRAINING SCHOOL**

March 31, 2014

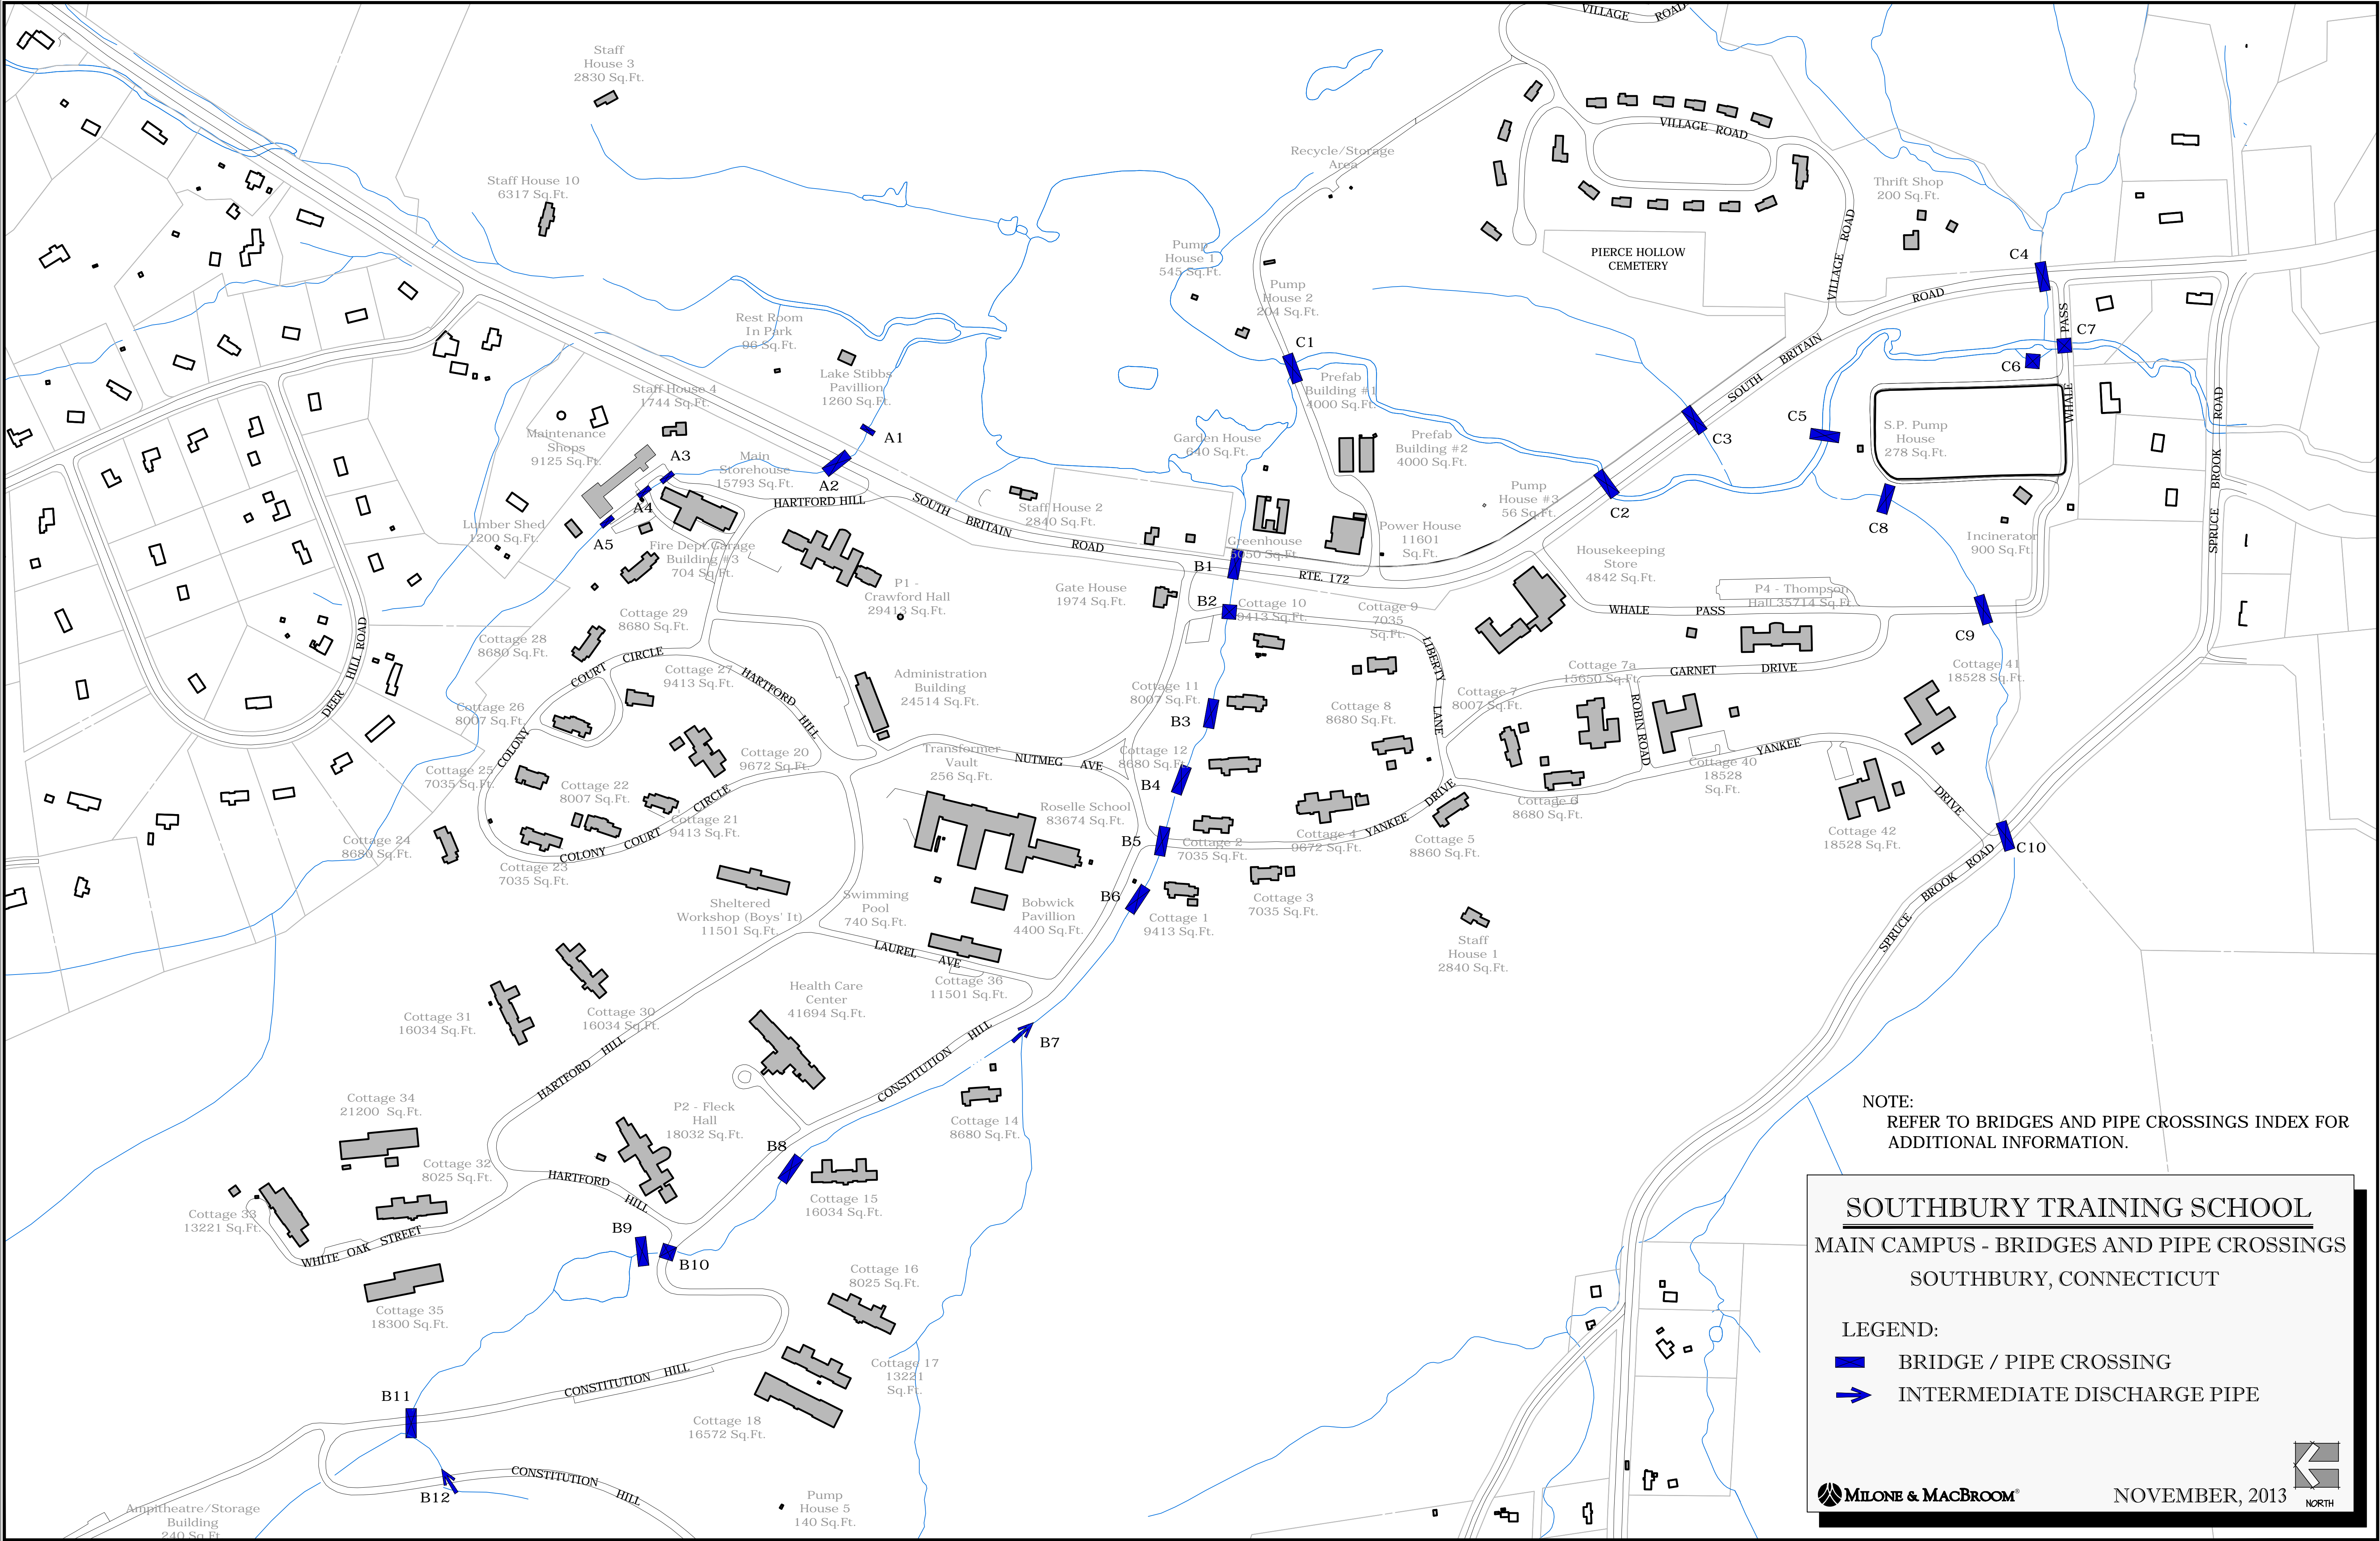
FIGURE 7 : BRIDGES & CROSSINGS PLAN

An inspection of the campus' bridges and pipe crossings was conducted. There were no major deficiencies on the main campus as routine maintenance of all such structures is evident.

Attached to many of these bridges are electrical and communication conduits that are representative of underground services. Any minor deficiencies are noted on the following Bridges and Pipe Crossings plan. An index sheet with more detail is included in the Appendix of this report.

- The roadway surface on Whale Pass, south of Thompson Hall is in need of paving as previously noted. Bridge crossing C9, shown on the Bridges and Crossings map, does not have a paved surface or guiderails. The roadway is currently comprised of base material only and has not been fine graded.

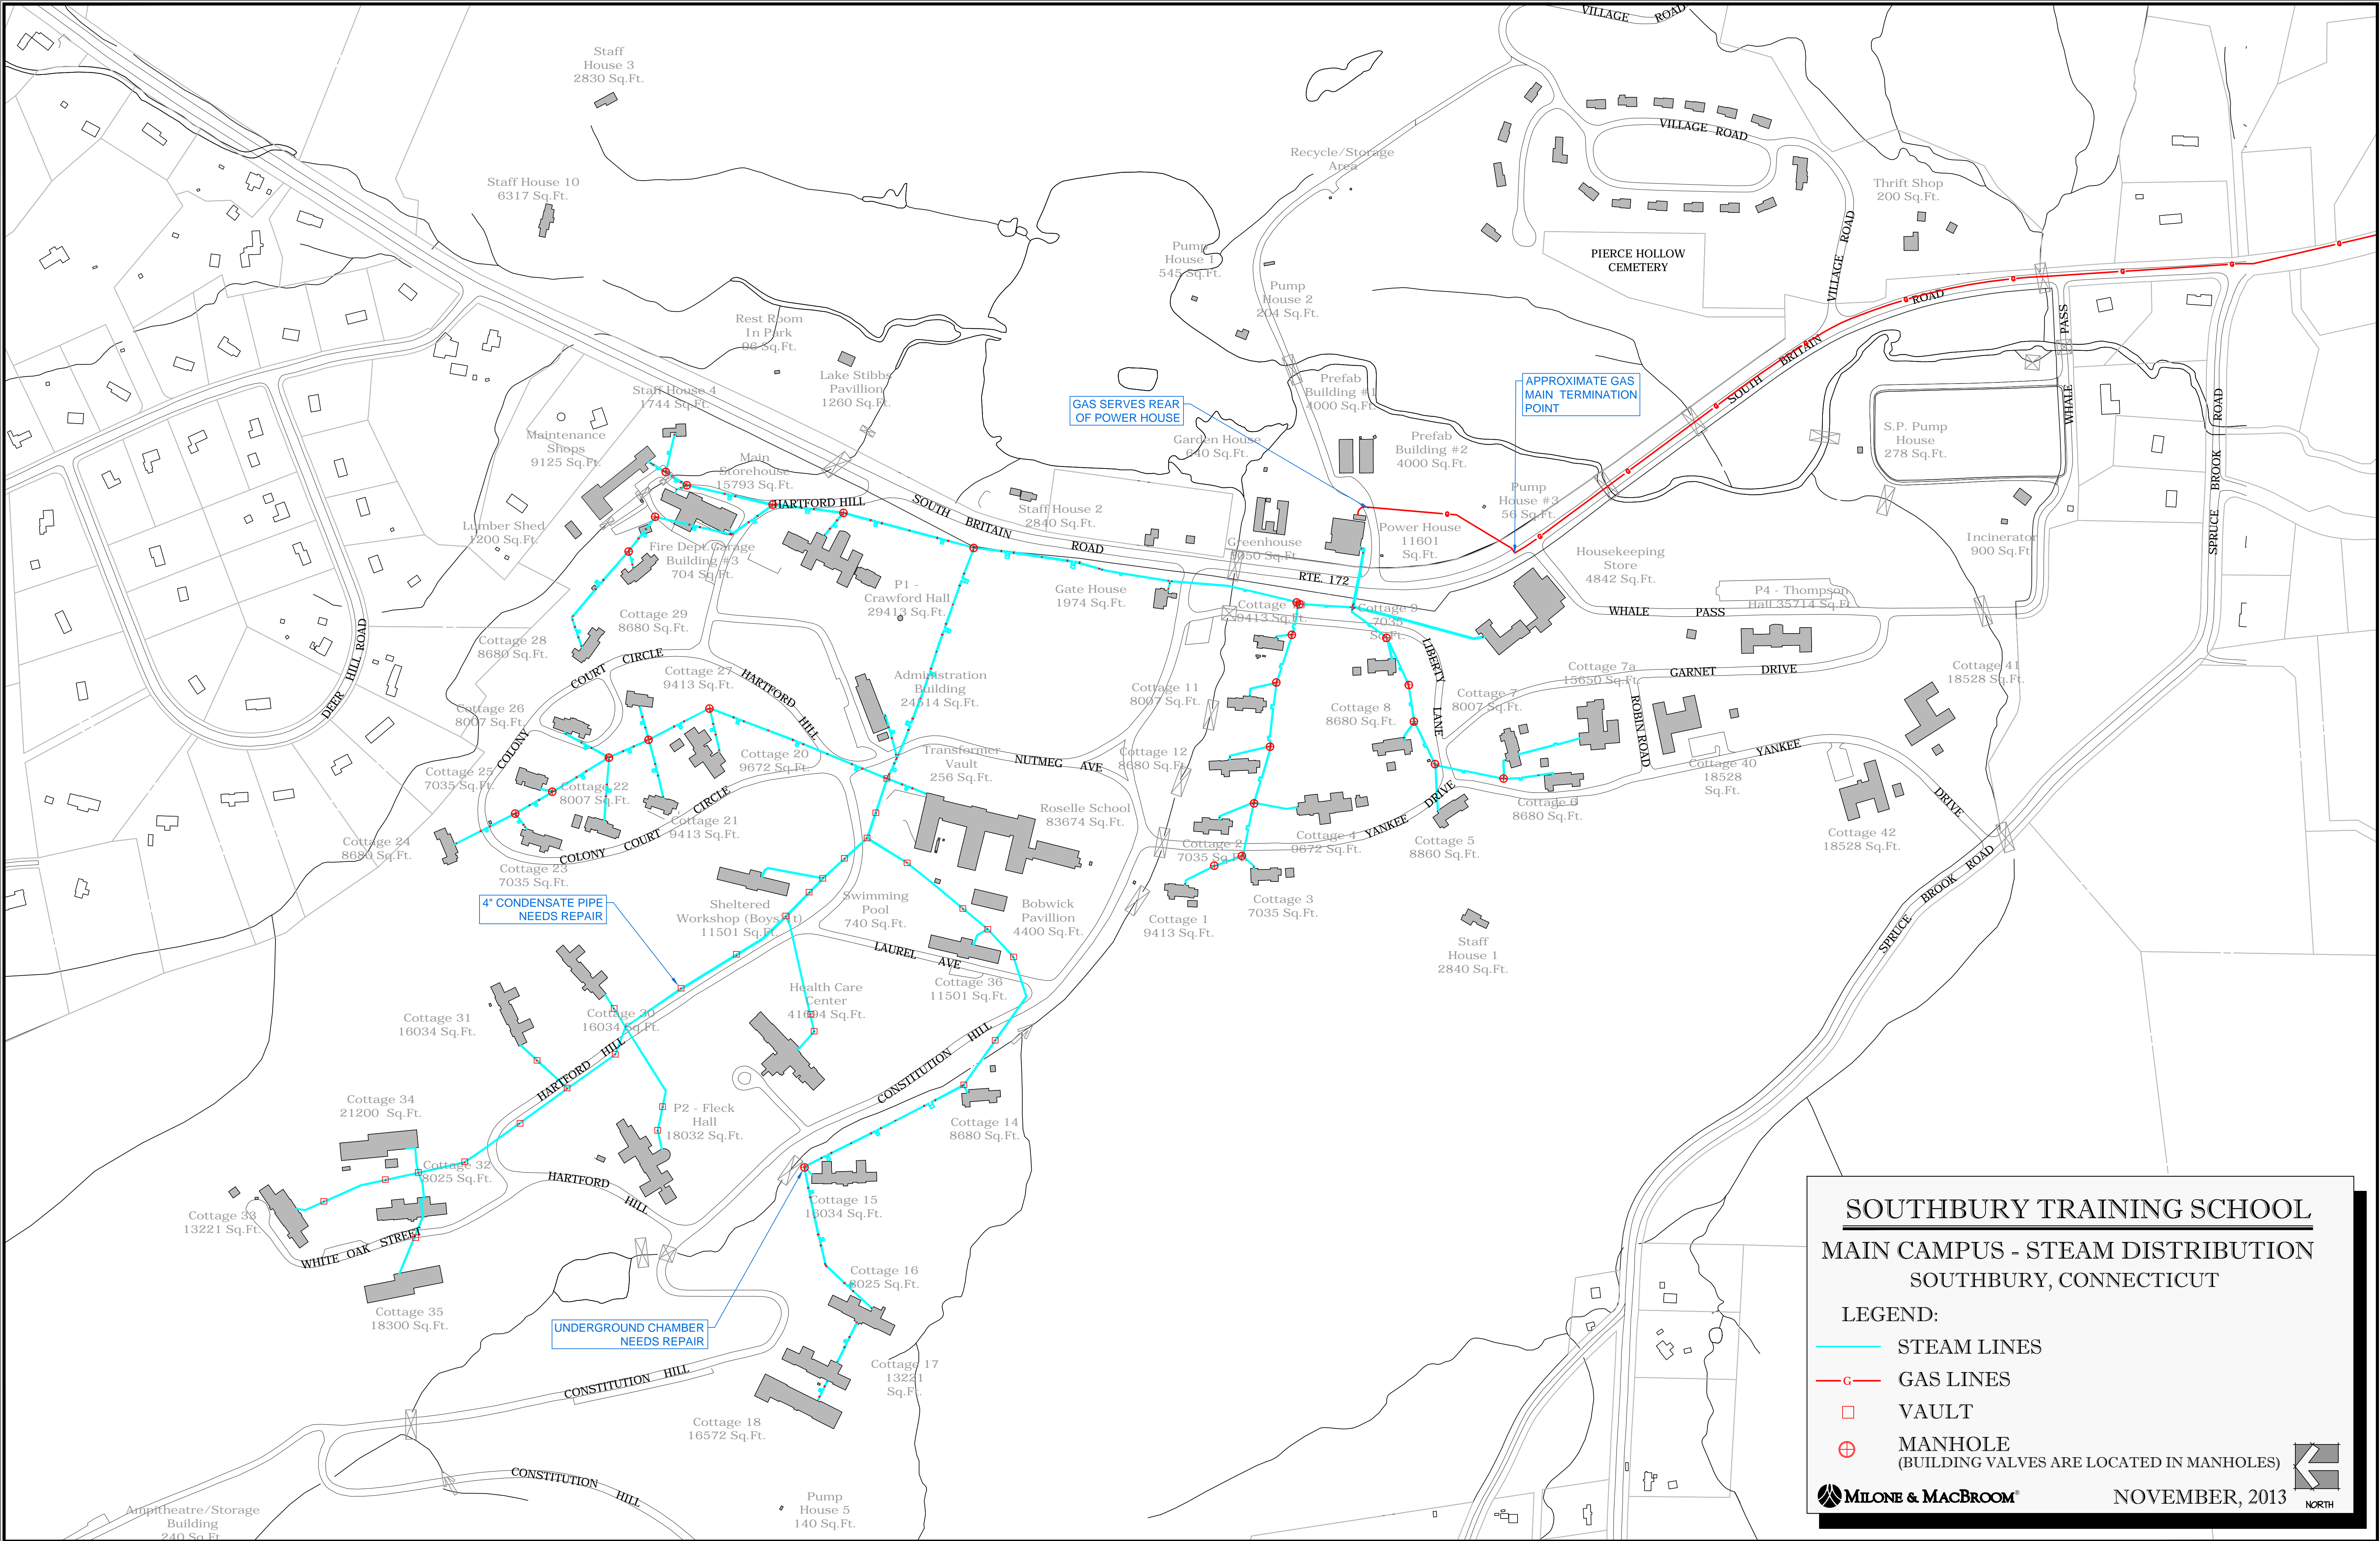
FIGURE 11 : STREAM DISTRIBUTION MAP

Recent Power House improvements include the replacement of the primary condensate return tank. Deficiencies to the steam line distribution system include the following:

- Groundwater seeping into the steam chamber at Cottage 15.
- A steam line repair from Cottage 16 westerly toward Cottage 17 was completed earlier this year. The repair extends partly into the hillside beyond the front entry of Cottage 16.

- Between the Sheltered Workshop and Cottage 30, there is a break on the 4 inch condensate line. This fault is located at the steam chamber.
- The steam distribution system is maintained on an as-needed basis and any breaks are fixed prior to the heating season. The last major replacement and repair of the steam line system was conducted in 1979. As-built mapping of this work is available upon request.
