At the request of the Town of Southbury, TLBA visited the Edgewood Bath and Tennis Club on June 10, 2020 to review the conditions of the swimming pool & pool decks as well as the recirculation, filtration and chemical control systems. Present at the site visit were George Bertram (Southbury Selectman), Hugh Sullivan, AIA (Bennett Sullivan Associates, Inc.) William Drakeley (Drakeley Pools), Susan Jones (Edgewood Bath and Tennis Club) and Michael Fortuna, AIA (TLB Architecture).

The swimming pool was built and opened in 2010. The pool is L-shaped, with a 6-lane, 25yard lap pool and a zero-depth entry area with multiple spray features. The pool is a pneumatically placed concrete with a stainless steel perimeter gutter system. Pool finish is a marbleized plaster, with ceramic tile at the zero-depth entry area.

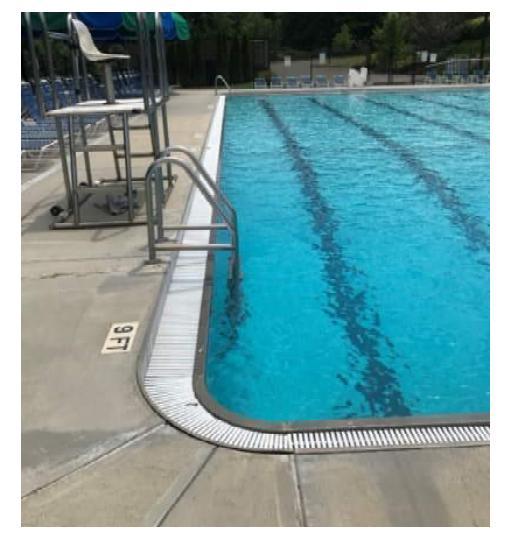
Left: Typical stainless steel gutter

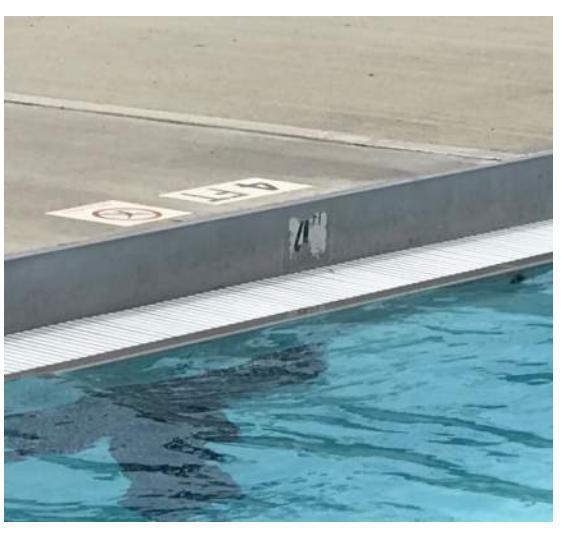
Right: Vertical depth markings on stainless steel in need of replacement.

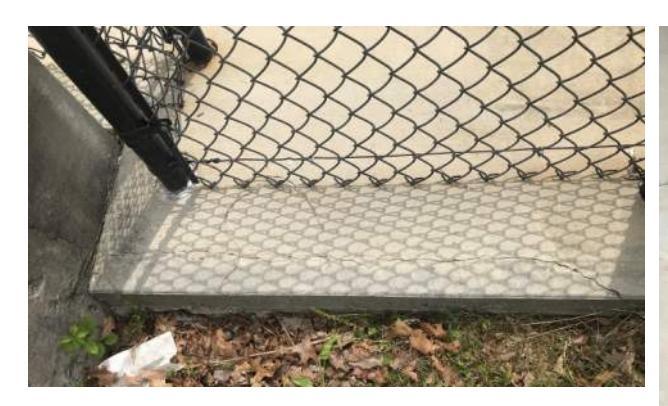
Above: Cracked concrete at edge of deck (near surge tank). If not repaired it will eventually break off.

- 1. Repair cracks by injecting an appropriate sealing material.
- 2. Repair spalls by chipping loose material and patching with a cementitious repair product.
- 3. Replace all elastomeric sealants in the deck expansion joints.

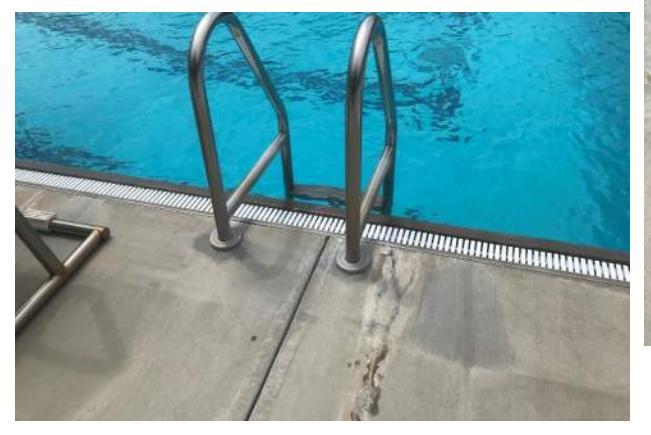
Below: Spalling concrete near ladder anchor.

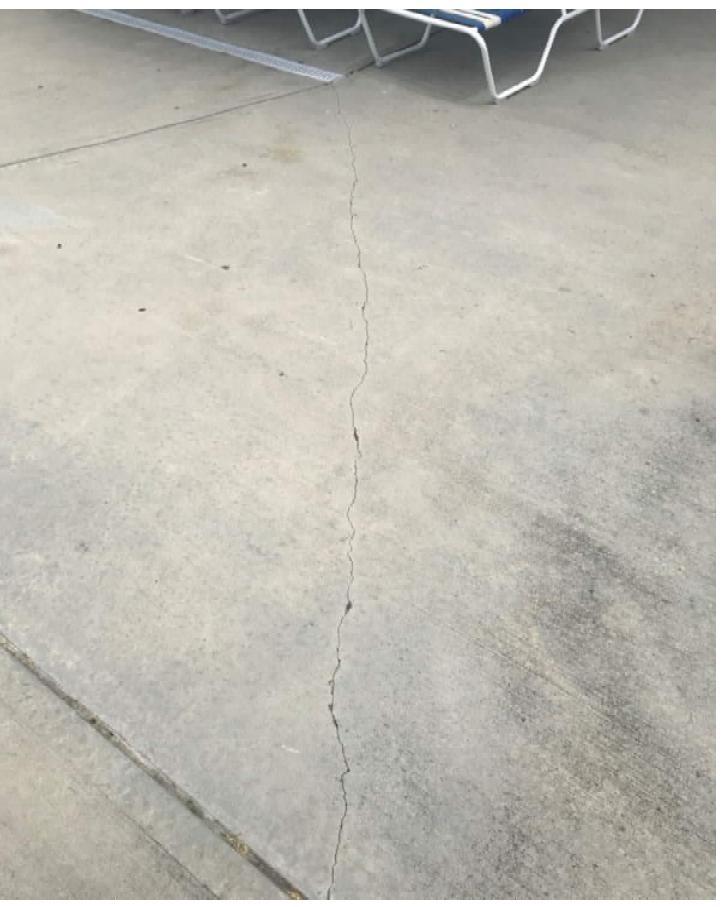
Above: typical deck crack.

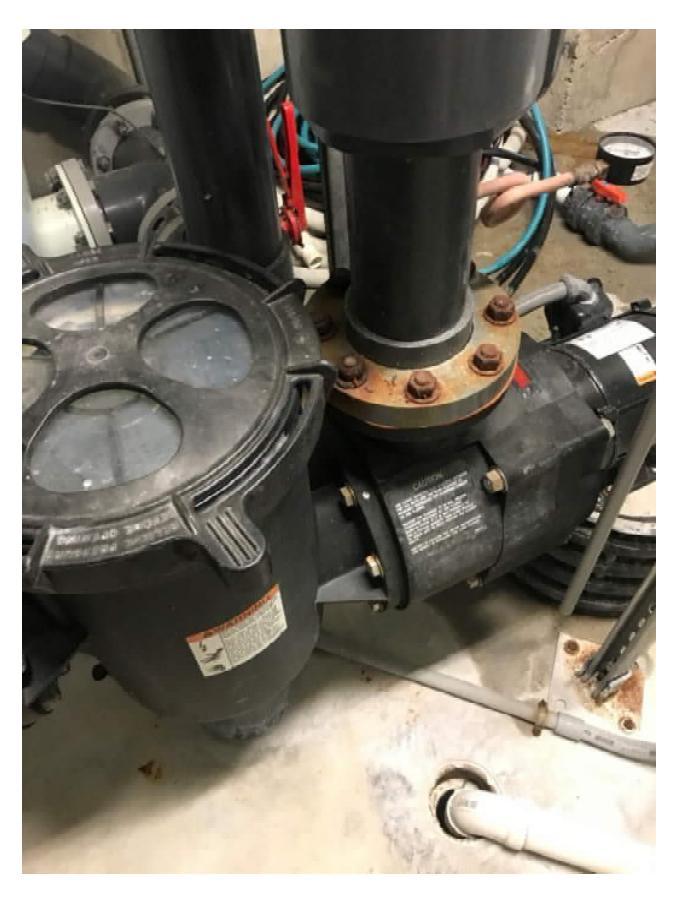
Rusted flange bolts.

- 1. The main drain covers have an expiration date for VGB compliance. The date should be verified, and covers replaced when required.
- 2. A number of flange bolts are rusted. It is recommended that bolts be replaced with stainless steel and that gaskets be replaced as a routine maintenance items when bolts are replaced.
- 3. The CO2 system should be in a ventilated enclosure.
- 4. Chemicals should be stored in a fire-rated enclosure.
- 5. It is recommended that the heaters be enclosed with a fence to prevent unauthorized access to the equipment.
