Project Description

Fence repair Bullet Hill School, Southbury CT

Town of Southbury Historic Buildings Commission

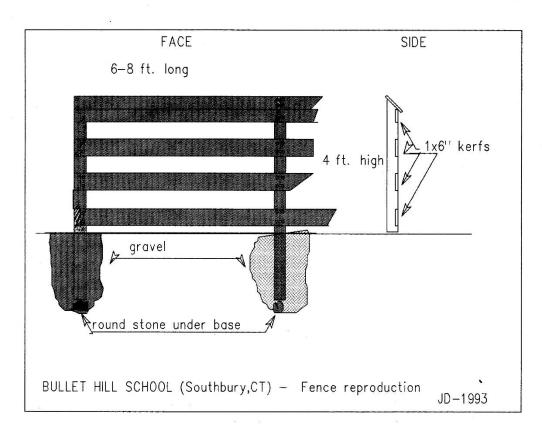
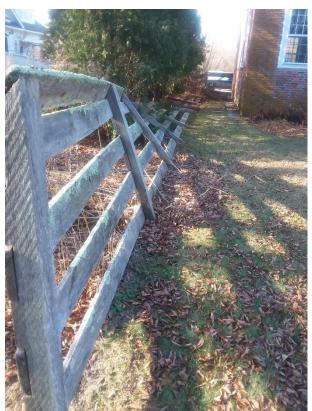
Attachments

61 foot section of 4 foot high rail (horizontal board) fence damaged by falling branches during May 2018 storm. Posts are broken at ground line and structure has collapsed.

- 1. Clear debris from work area with consideration to salvage any whole, re-usable parts.
- 2. Remove broken post sections below ground level.
- 3. To re-use the same post holes remove enough ground materials to set new posts at 2 foot depth.
- 4. Temporarily set new 4x4 pressure-treated posts and mark the placement of cuts for height and those intended to receive the rails. Match former spacing maintaining a reasonably true line-of-sight (design diagram attached).
- 5. Remove posts from holes and make the joinery and top cuts.
- 6. Set in place and plumb posts using stone/gravel back-fill.
- 7. Re-attach as many of the salvaged rails as practical using hot-dipped galvanized nails or exterior grade screws.

There is an attached perpendicular fence section which shares a corner post. That section is erect but is out of plumb due to the stress and weight of the attached wreckage. At first glance its posts appear to be intact. If so, it might be possible to force it back into place and then adjust the gravel fill once the adjacent stress is eliminated. A supplementary correction might be to employ the use of "sister" supports.
