Southbury, Ballantine Park Pool Facility Evaluation Report

Ballantine Park Pool
611 Old Field Road
Southbury, CT 06488

ENGINEER'S REPORT

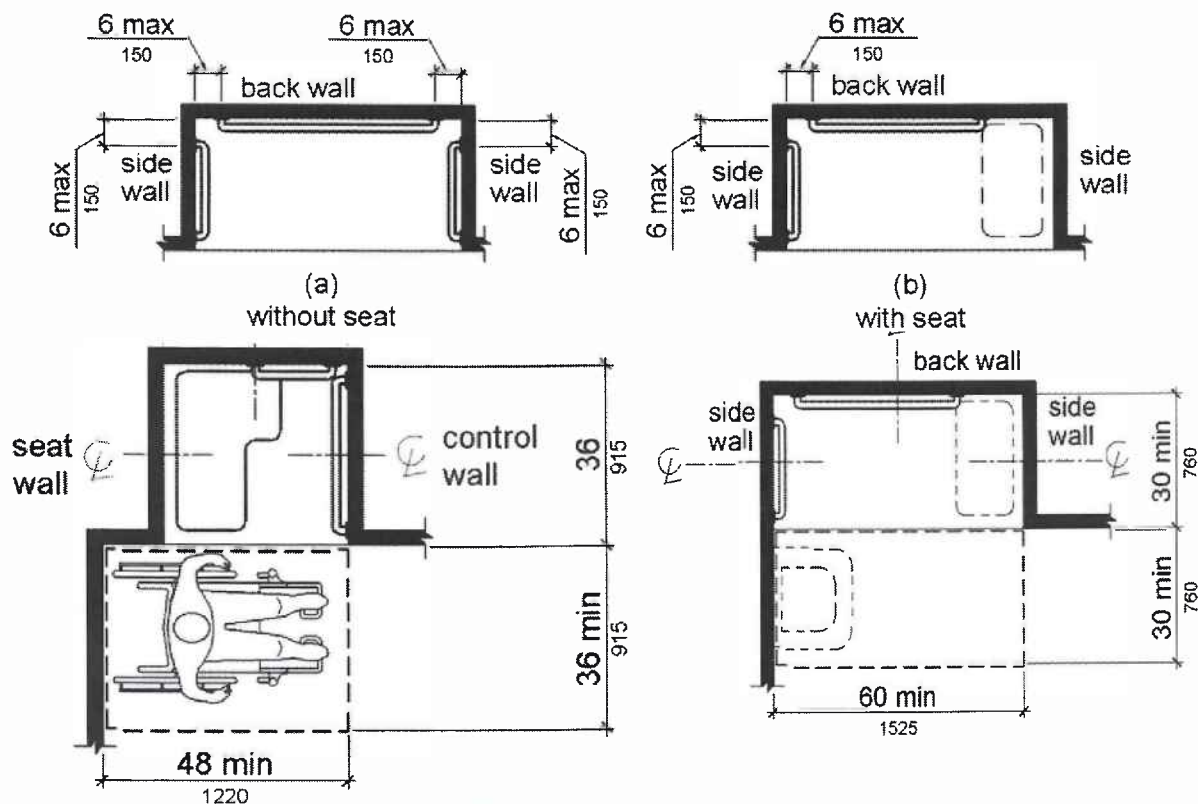
Figure 13 - ADA shower

The current ADA showers do not have a spray unit with a 59 inch long hose. Refer to **Figure 13**.
